STUDY PROGRAM TO DEVELOP AND EVALUATE DIE AND CONTAINER MATERIALS FOR THE GROWTH OF SILICON RIBBONS

Miami Research Laboratories
Eagle-Picher Industries, Inc.
Miami, Oklahoma 74354

QUARTERLY REPORT NO. 4

OCTOBER 1978

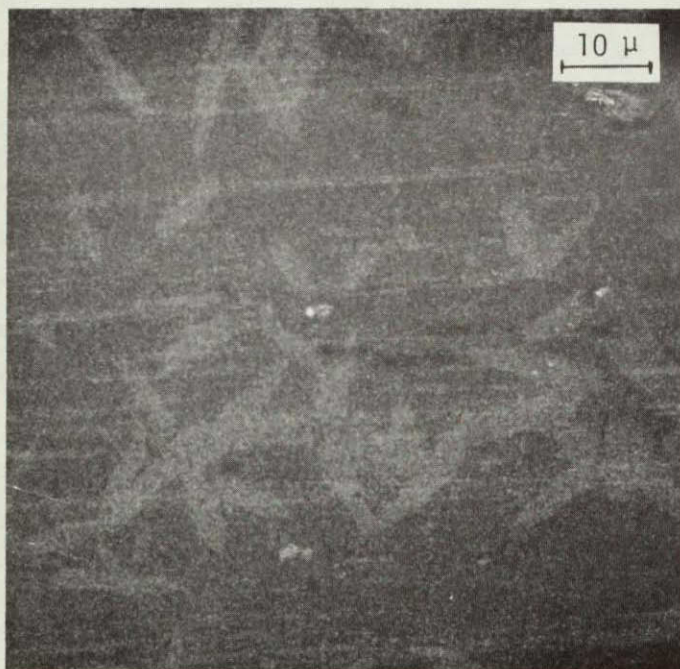
Figure 5. SEM and EDX Investigation of Thermal Etching Details in CNTD SiC Coating

The apparent bright spots in the optical photomicrographs were further investigated using the SEM in the EDX mode. The coatings were found to be free of metallic impurities and a silicon map across an area containing these patterns revealed no substantial variations in silicon content related to these features, (see Figure 5).

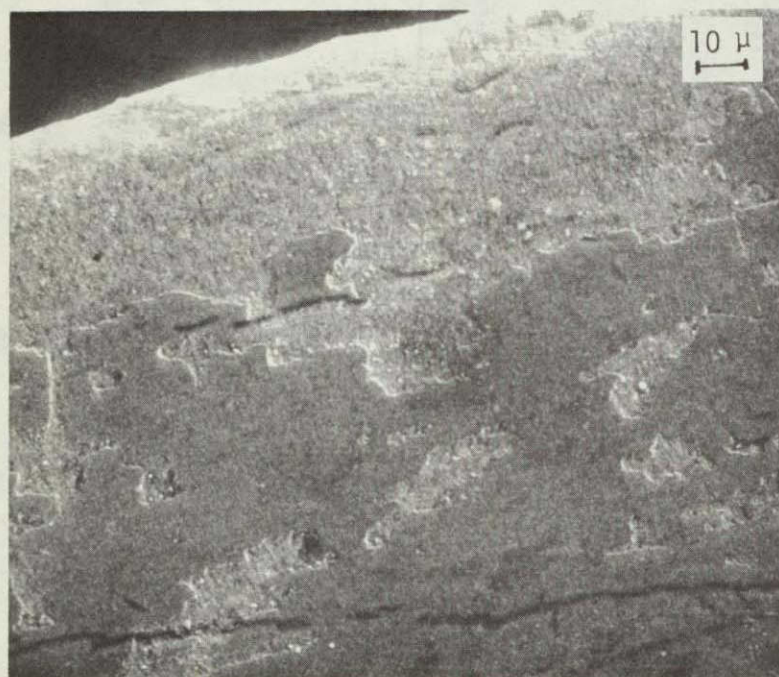
Figure 6. Further SEM Investigation of Details of CNTD SiC Coating Microstructure

The thermal etch was not uniform in its action on the CNTD coating. This is shown in Figure 6-a. Silicon maps were made and no substantial variation in silicon content was noted from one region to another. The greatest achievement to date in revealing the grain size potential for CNTD fabrication in this program is shown in Figure 6-b. Grains as small as 0.25μ (2500 \AA) are revealed. While this microstructure has not been shown to be representative of all regions, or all samples, the potential of CNTD fabrication for production of dense, fine grained, SiC coatings is thus demonstrated.

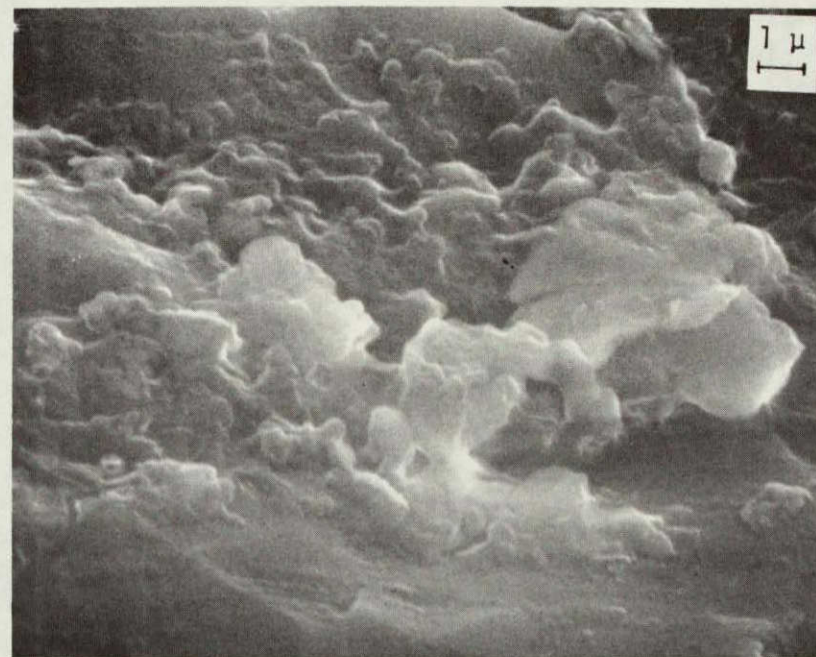
Figure 7. Fractured Surface of CNTD Si_3N_4 Coating on Hot Pressed Si_3N_4
w/4 wt% MgO.

The microstructural information obtained for the CNTD Si_3N_4 coatings has been observed on fractured specimens. These coatings appear extremely dense. Figure 7-a shows the CNTD structure at 2000X and suggests a grain size on the order of 20 to 25 μ . A larger magnification (Figure 7-b) reveals grains on the order of 1 μ or less, demonstrating the capability of CNTD fabrication to produce reasonably fine grained Si_3N_4 .

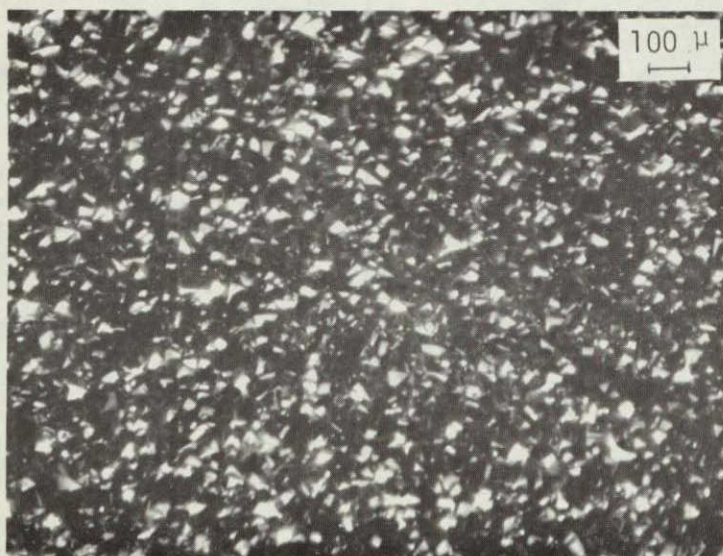
Figure 8. Candidate Materials Set 4-A at Low Magnification

The candidate materials set 4-A exhibited a relatively coarse crystalline appearance before grinding as shown in the optical photomicrograph in Figure 8-a. The typical appearance after grinding is illustrated in Figure 8-b. The coatings were translucent with the coloration observed to vary from faint grey to faint tan or a deeper brown from sample to sample but were reasonable uniform across a given sample.

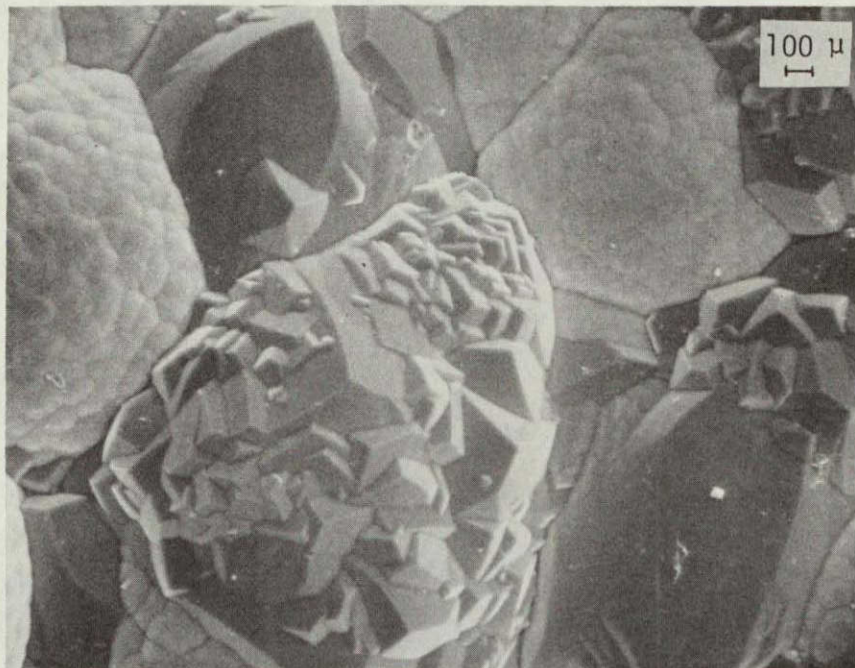
Figure 9. Scanning Electron Photomicrograph of Candidate Materials Set 4-B Coating known to Contain both Crystalline and Amorphous Characteristics

PP-40, Part 384-A at 330X

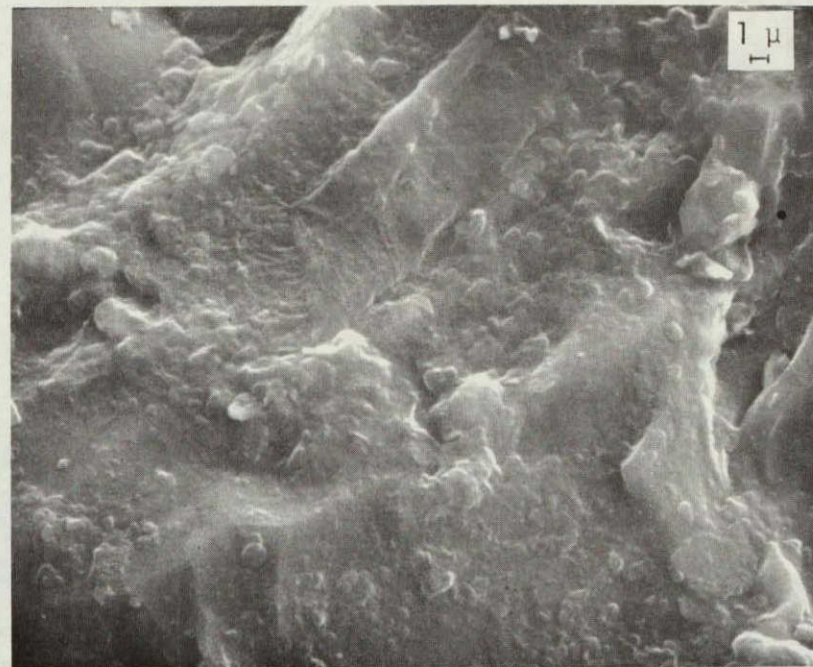
Figure 11. SEM photomicrographs of Candidate Materials Set 4-B
Coating, Fractured Surface

The grain structure of the group 4-B coatings was studied on fractured surfaces with the SEM. Some results are shown in Figure 11. While larger grains apparently coexist with smaller ones, grains as small as 1μ and less are distinguishable in Figure 11-b.

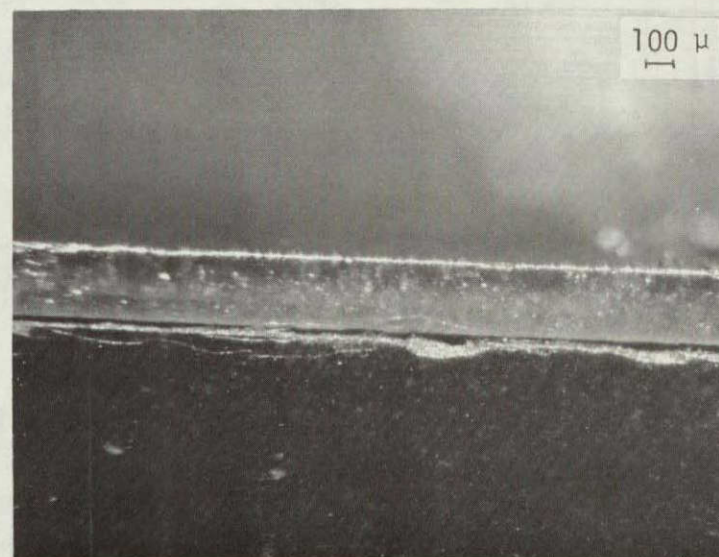
Figure 13. Post sessile Drop Conditions for CNTD Si_3N_4 on "Impure",
 PP-30, Si_3N_4 Substrate
 PP-30, Part No. 3

The silicon drop has been observed to "pop loose" from the coated specimen during cool-down in some cases (see Figure 13) and at least partially separate in others (see Figure 14-a). The CNTD coating has been observed to partially separate from the hot pressed substrate in certain runs with the PP-30, "impure", substrate as shown in Figure 13-b. Sessile drop experiments have not proceeded far enough to establish the frequency of this phenomenon. The CNTD structure is shown to be coherent at this magnification.
